**HV Power hints and tips:
PQ-Box 100 Power Quality Recorder**

Issue 8a

Connecting to common VT secondary configurations:

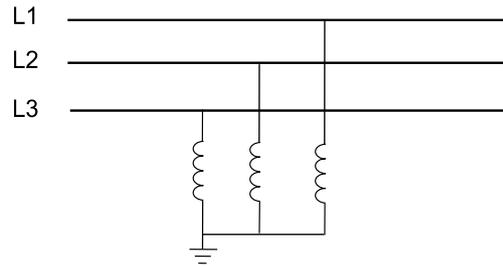
Primary VT connection:

Secondary VT & PQ-Box 100 Connection:

3 Ph Wye +N (grounded neutral)	3 Ph Wye +N (grounded L2)	3 Ph Wye (grounded L2) <small>VT secondary neutral point not available</small>

<p>PQ-Box 100 Setting: 4 Wire</p>

<p>PQ-Box 100 Setting: 3 Wire</p>

Please refer to PQ-Box 100 hints and tips, Issue 3a, for details on the effect of 3-wire and 4-wire settings.

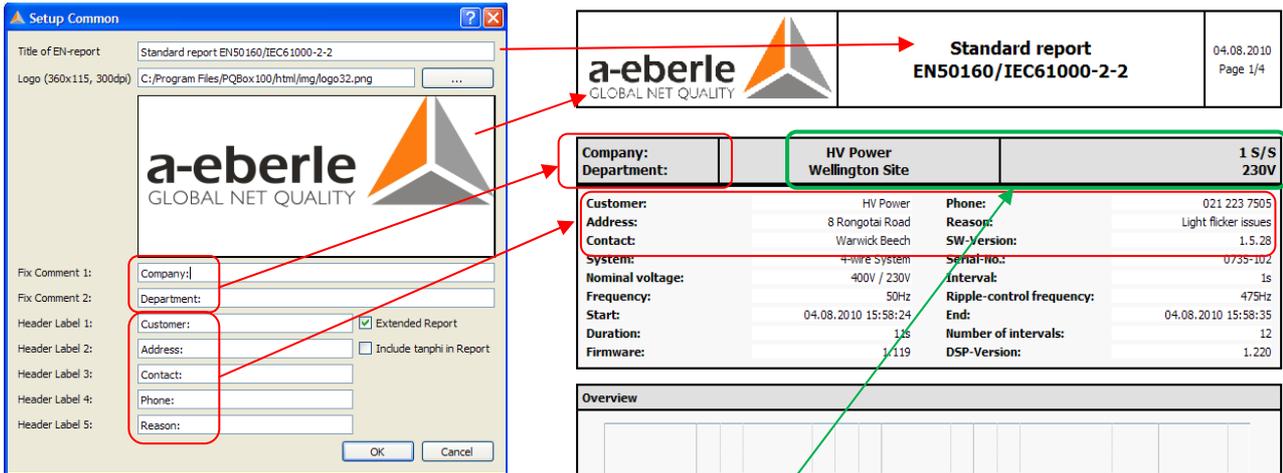
The “Setup Common” dialog box (main menu Setup/Common) sets the default **labels** for *Fix Comment 1 & 2*, and *Header Label 1-5*. These default **labels** are used in the printouts of newly downloaded of data from the PQ-Box 100.

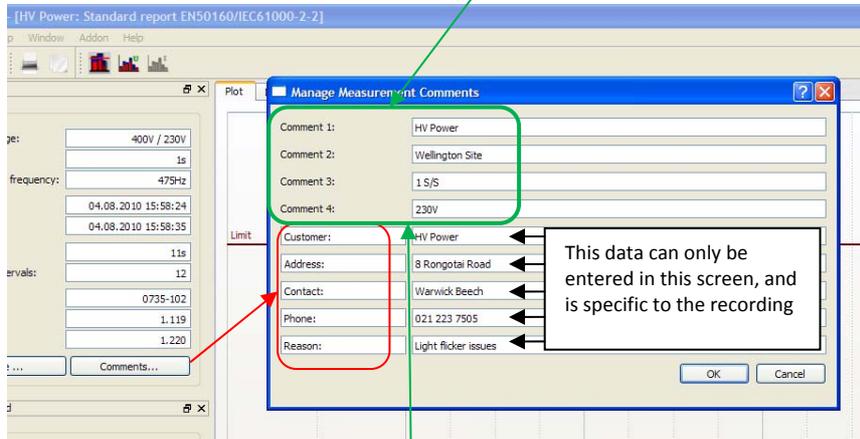
The data for each of these labels can be edited by using the “Comments button”. Additionally the *Header Label 1-5* can also be edited for an individual file, overwriting the label for that specific file only.

Note that the Comment 1, 2, 3 & 4 data shown above “Manage Measurement Comments” dialog box, is the same data that appears in File Load Dialog box (below). This data can be entered or edited in either location.

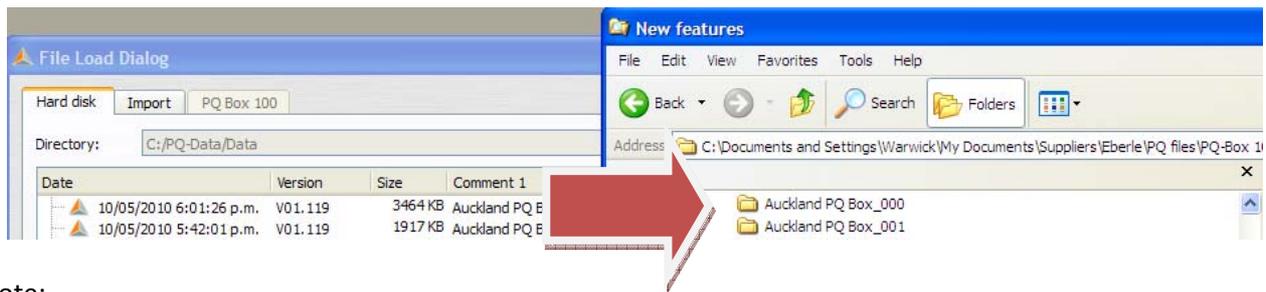
Data folder names and “Comment 1 text”

With WinPQ mobil V1.5.38, the folder created for the downloaded data will be named based on the “Comment 1” text, but suffixed with a sequential number in the format “_000”. This auto assigned suffix allows the “Comment 1” text not to be unique.

If there is no “Comment 1” text entered, then the folder will be named based on the start date/time of the recording, i.e. 20100924_1303_000.

1. If the “Comment1” text is changed within WinPQ mobil software, the the data folder name will be changed as described above
2. If the “Comment1” text is changed outside of WinPQ mobil (e.g. by using Notepad), the data folder name will not be changed when running WinPQ mobil software*
3. If the data folder name is changed outside of WinPQ mobil software, the data folder name will not be changed when running WinPQ mobile software*
